F/V Seahawk 68 Ship Grounding in American Samoa: Environmental Report, October 2020

On May 22, 2015 the Taiwanese longliner F/V Seahawk #68 ran aground on the reef at Avatele Point near the Pago Pago Airport causing major damage to the coral reef at that site. Approximately 1,200 – 1,500 gallons of diesel fuel, 200 gallons of lube oil, and 75 tons of fish were on board. Within one month of running aground the fuel, oil, and other hazardous materials were removed by a local contractor, SOLAR Inc. In June 2015, DMWR, assisted by NPS, also conducted a rapid biological assessment and removed debris that posed an entanglement hazard for marine organisms. Refer to Appendix 3 for the report from

F/V Seahawk 68 Ship Grounding in American Samoa: Environmental Report, June 2015

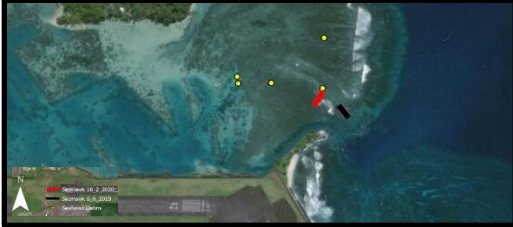
Figure 1: Map showing movement of the vessel. The previous location of vessel is indicated in black and current location indicated in red.

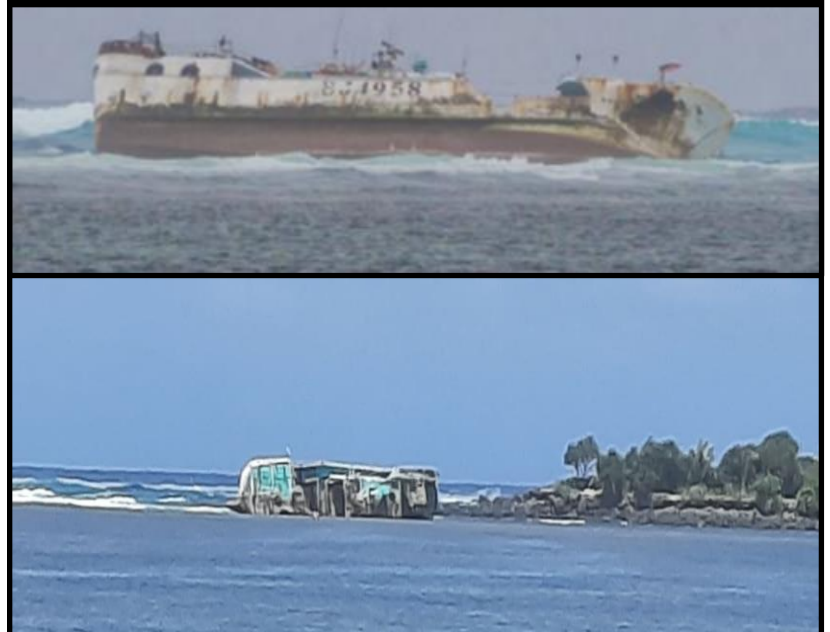
The assessment confirmed that the vessel had moved significantly from the original grounding location (Figure 1, Image 1). Following the assessment, it is believed that the movement occurred because the propeller which is still lodged in the original location had been acting as an anchor and holding the vessel in place (Image 2). Over time, high wave and wind action caused degradation to the hull and the propeller subsequently broke free creating a large hole in the hull and freeing the vessel. This allowed the vessel to move further onto the reef flat, towards the shore. The deck of the vessel is now parallel to Coconut Point with the deck facing towards shore

Image 1: Above - Orientation of the vessel (as seen from Coconut Point) prior to it shifting. Below - Present orientation of the vessel from the same vantage point.

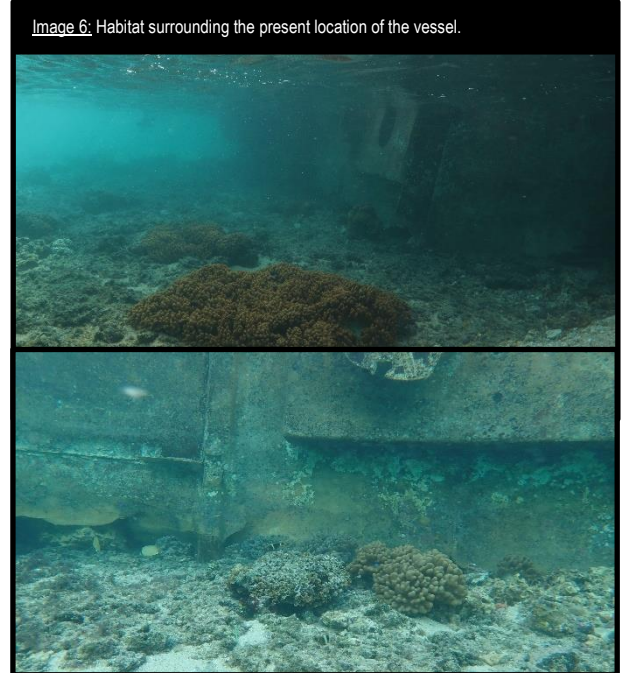
The vessel currently sits atop a rubble field (Image 6). This area is highly exposed with strong wave action for most of the year. As a result, the reef crest and immediate reef flat are primarily composed of rubble with only isolated colonies of *Porites*, *Pavona*, and *Sinularia*. Therefore, we believe that the damage to the surrounding habitat through vessel movement has been minimal to date.

Image 6: Habitat surrounding the present location of the vessel.

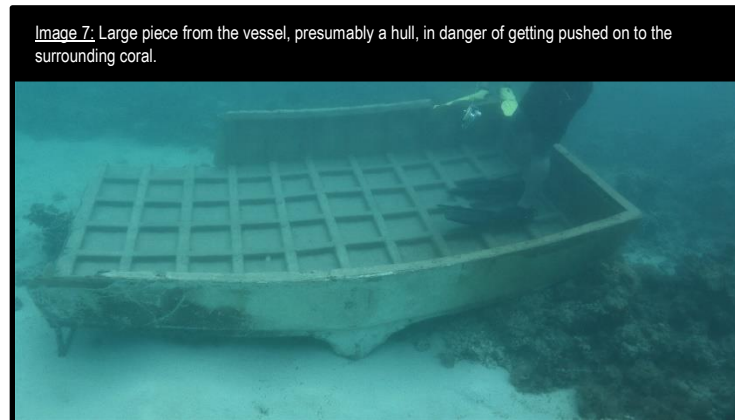
Image 7: Large piece from the vessel, presumably a hull, in danger of getting pushed on to the surrounding coral.

piece (8' X 12'), presumed to be a hatch from the vessel (Image 7). This piece was found in a sandy patch adjacent to a large *Acropora* thicket. Another large piece from the body of the vessel was found by Nu'uuli Pools lodged in living coral and there is evidence of physical damage to coral surrounding the debris.

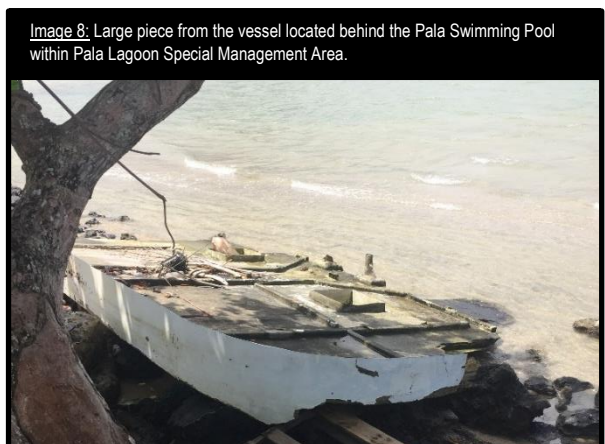
Image 8: Large piece from the vessel located behind the Pala Swimming Pool within Pala Lagoon Special Management Area.

hatch) from the vessel adjacent to the swimming pool (Image 8).

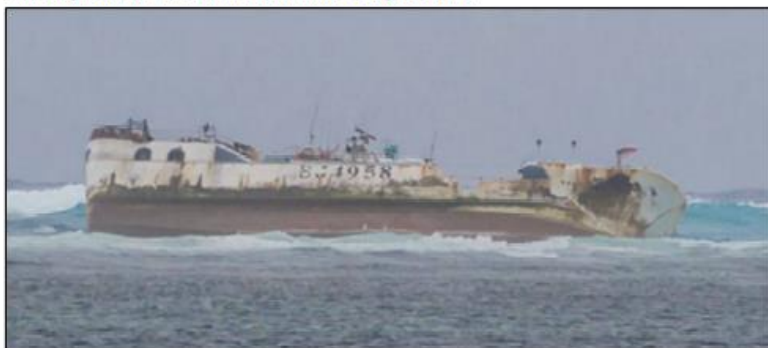
1: F/V Seahawk #68 grounded at Avatele Point, Nu'uuli

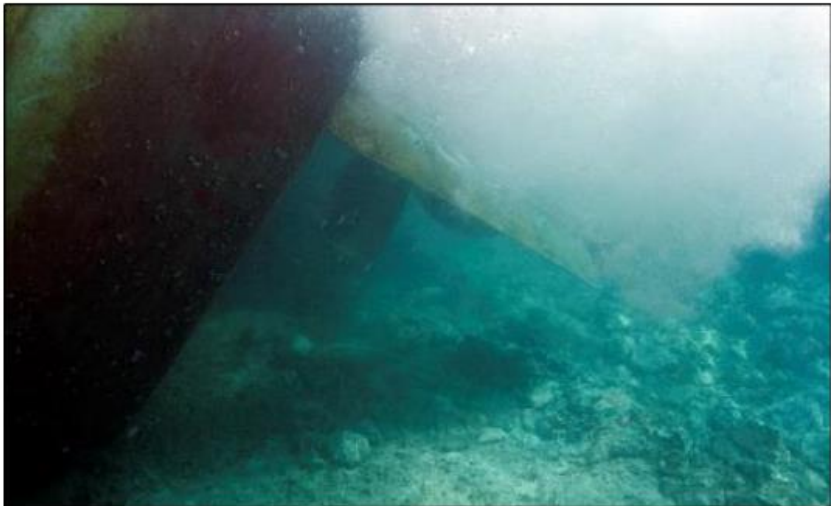
5: Reef pulverized to rubble by the hull

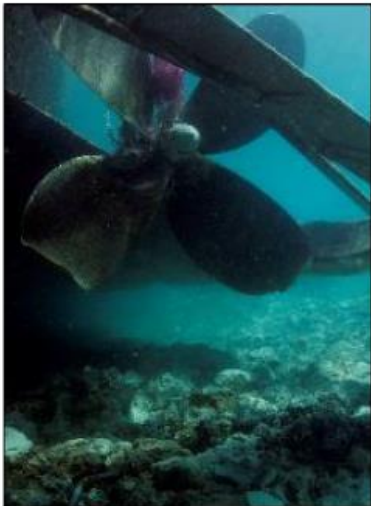
6: Reef pulverized to rubble

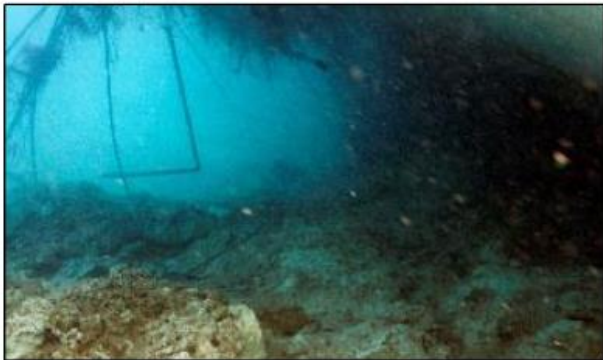
7: Vessel gouged large grooves into the reef

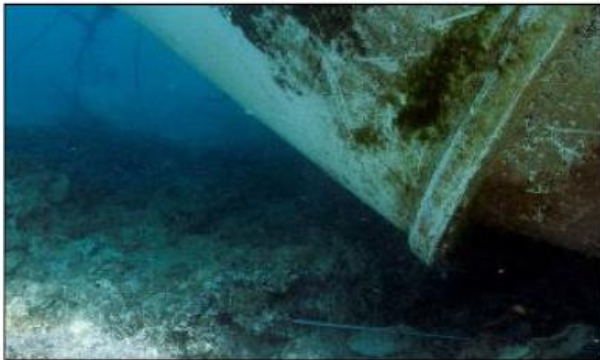
8: Part of the hull resting on the substrate

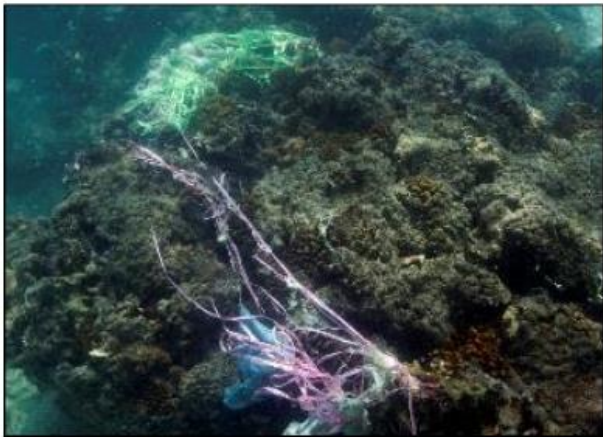
9: Plastic debris getting stuck on the coral

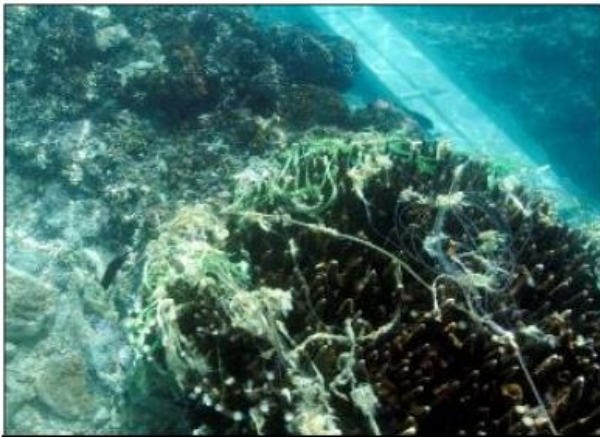
10: Broken coral wrapped in fishing lines

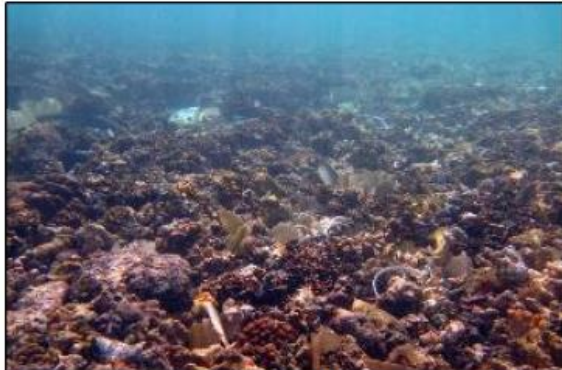
11: Debris from the grounded boat on the coral reef

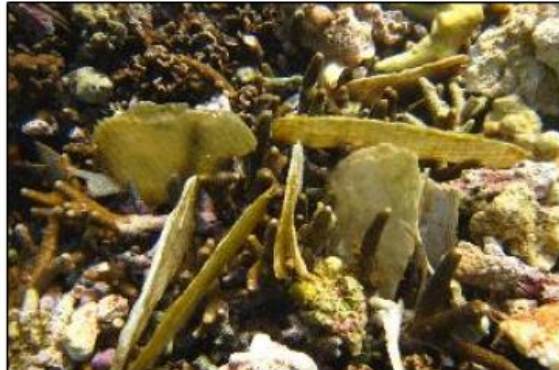
12: Fiberglass pieces from the boat hull

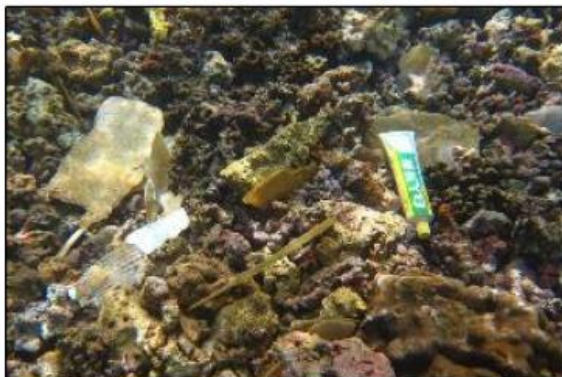
13: Fiberglass pieces and debris from the vessel

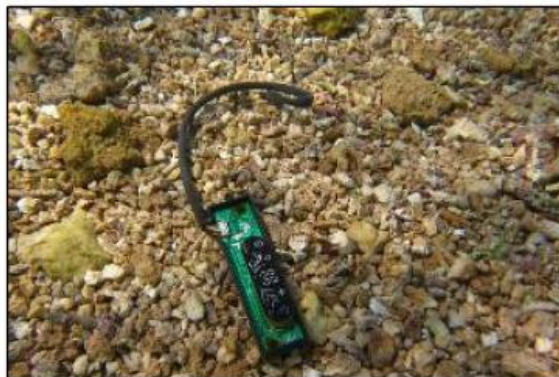
14: Electronic debris from the vessel

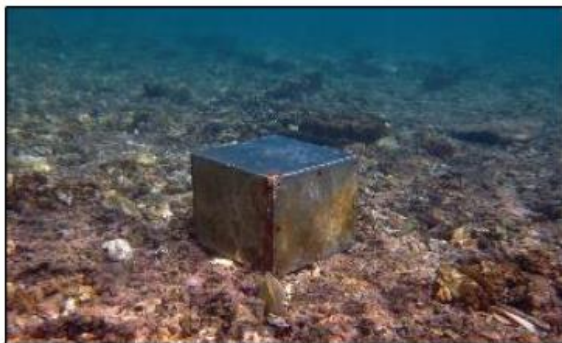
15: Large metal objects cause physical damage to coral colonies during strong currents and high surf

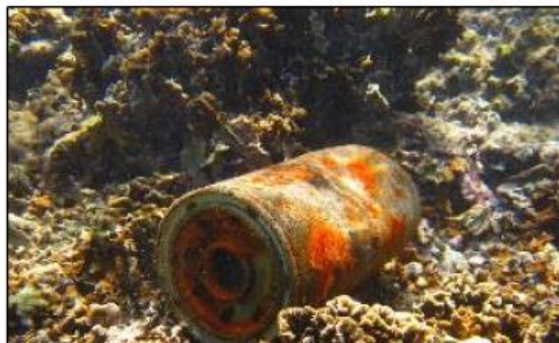
16: Hazardous waste (oil filter)

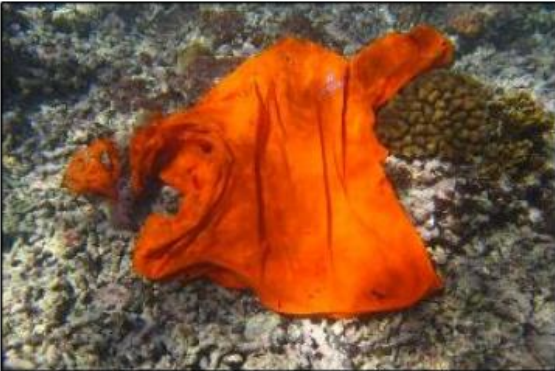
17: Clothing and material entangled with coral

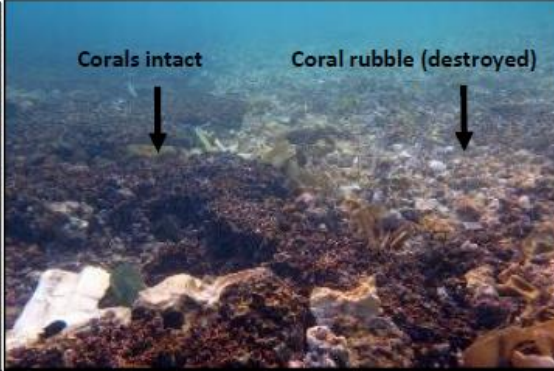
18: Damage to coral directly in front of the vessel

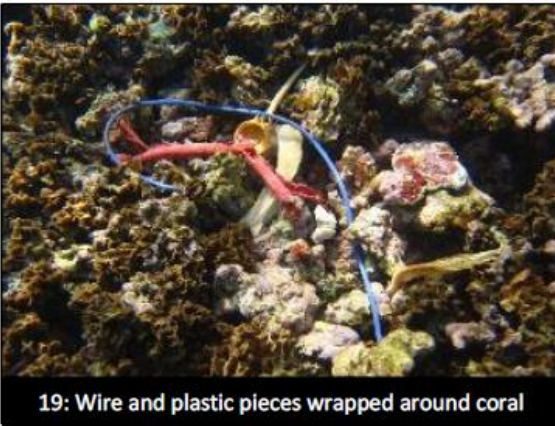
19: Wire and plastic pieces wrapped around coral

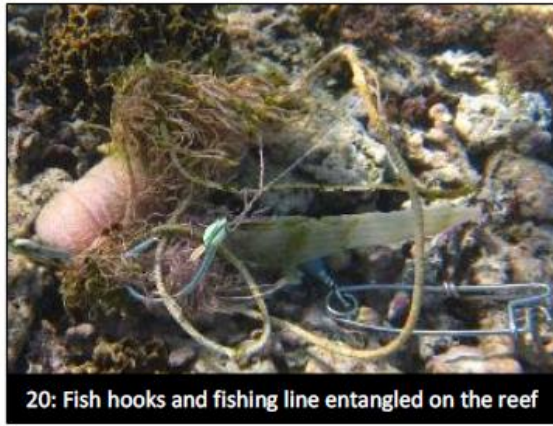
20: Fish hooks and fishing line entangled on the reef
