F/V Seahawk 68 Ship Grounding in American Samoa: Environmental Report, October 2020

On May 22, 2015 the Taiwanese longliner F/V Seahawk #68 ran aground on the reef at Avatele Point near the Pago Pago Airport causing major damage to the coral reef at that site. Approximately 1,200 – 1,500 gallons of diesel fuel, 200 gallons of lube oil, and 75 tons of fish were on board. Within one month of running aground the fuel, oil, and other hazardous materials were removed by a local contractor, SOLAR Inc. In June 2015, DMWR, assisted by NPS, also conducted a rapid biological assessment and removed debris that posed an entanglement hazard for marine organisms. Refer to Appendix 3 for the report from

F/V Seahawk 68 Ship Grounding in American Samoa: Environmental Report, June 2015

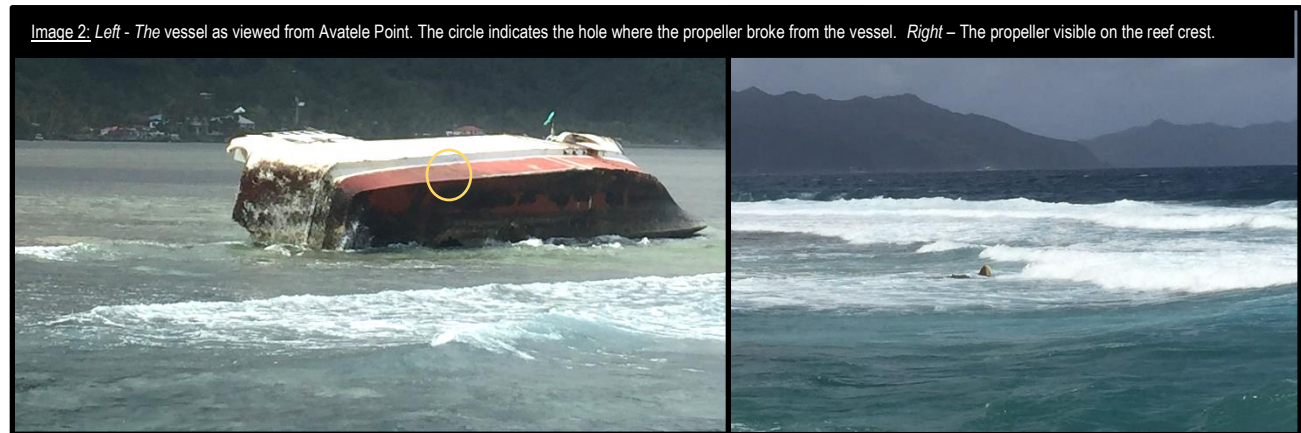
The assessment confirmed that the vessel had moved significantly from the original grounding location (Figure 1, Image 1). Following the assessment, it is believed that the movement occurred because the propeller which is still lodged in the original location had been acting as an anchor and holding the vessel in place (Image 2). Over time, high wave and wind action caused degradation to the hull and the propeller subsequently broke free creating a large hole in the hull and freeing the vessel. This allowed the vessel to move further onto the reef flat, towards the shore. The deck of the vessel is now parallel to Coconut Point with the deck facing towards shore

and the stern facing towards Pago Pago Airport.

Without the propeller anchoring the vessel to the reef it was visibly moving during the assessment and appears highly unstable. This increases the urgency for removal, particularly as we approach cyclone season (November 2020 – April 2021).

1. The vessel should be removed as soon as possible due to the instability of the vessel and high potential for continued migration onto the reef flat, as well as, a high likelihood of pieces from the vessel continuing to break off and damage coral reef habitats.

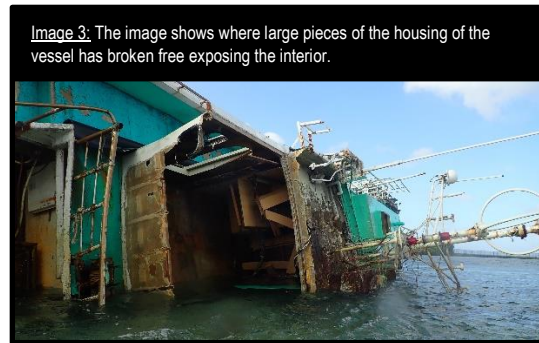
exposed due to sizeable, structural pieces breaking off.

The Seahawk has sustained significant damage due to its exposure to strong wave energy and high winds (Image 3). The stern of the vessel, which had been most exposed in its previous location, has begun to break apart and large pieces have been visibly removed by the elements. The fuel tank has separated from the vessel and now lies adjacent to the body of vessel. Several sections of the interior

are now

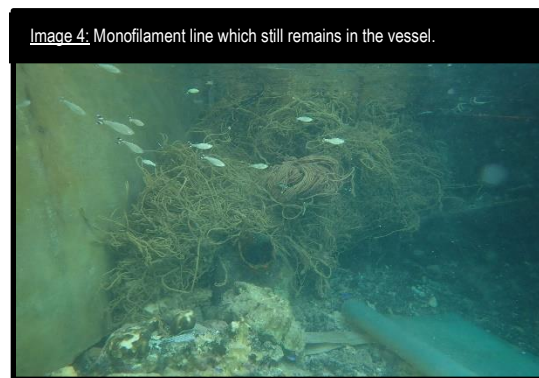
These may have been previously inaccessible but have become exposed as the vessel body breaks apart.

It is likely that the vessel will continue to break up and large pieces will continue to be deposited on the surrounding reef flat and shoreline (Image 5). This could cause direct physical damage to the surrounding coral communities and pose entanglement hazards for

marine organisms in the area, particularly turtles that utilize the area for feeding. Of particular concern is the fishing line which poses a high risk of entanglement. Thus, this is a high priority for removal.

4. The removal could be undertaken in two phases. The first phase would prioritize the remaining monofilament line, large debris on the reef flat, and any loose pieces in danger of breaking from the vessel. The second phase would target the remaining pieces of the vessel.

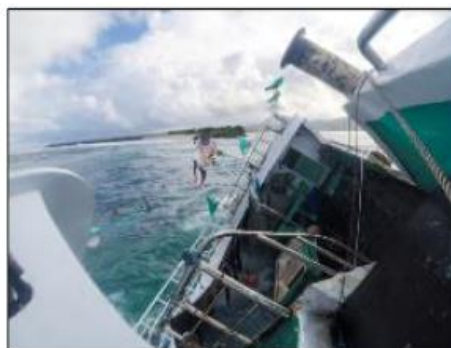
2: View from vessel towards front deck

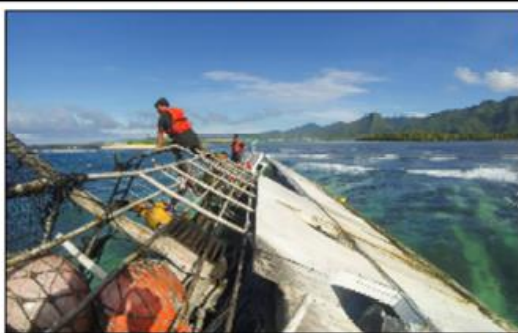
3: View from vessel towards front deck

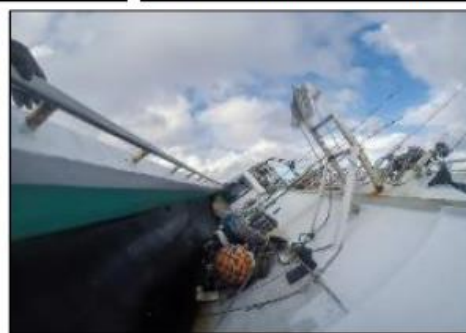
4: View from vessel towards front deck

The vessel is currently laying on its port side, partially on the shallow reef and partially in deep water and in the middle of the surf zone. The impact of the ship grounding to the surrounding coral reef environment includes:

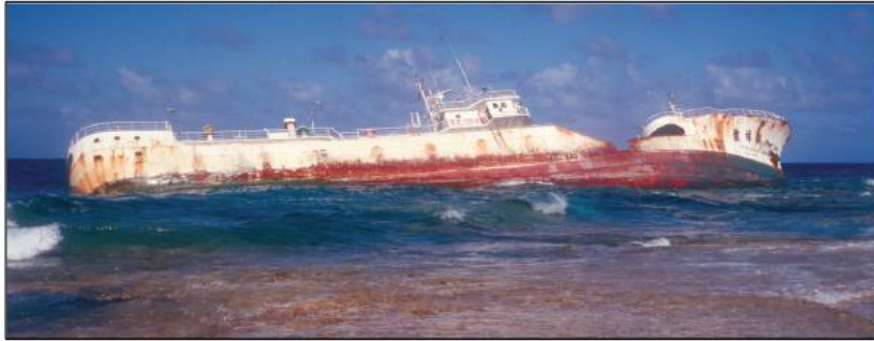
Case study: Grounding of the Taiwanese longliner at Rose Atoll in 1993

- Destroyed a large section of the reef
- High volume of **ship-related debris** on the reef slope and reef flat
- Leaking **diesel fuel** polluted the water

- The ship broke apart within 6 weeks due to strong wave action
- Surveys found that much of the wreckage and its debris remained on the reef slope and reef flat for years after the grounding

- Over time the iron corroding from the wreckage (structural steel, engine block, zinc anodes, copper) maintained an **algal bloom** that **inhibited recovery of the reef system** (spreading the entire length of the SW reef)

- **“In the event of future groundings, containment of the contaminant spill and prompt removal of all debris is recommended to preserve ecosystem integrity.”** (Schroeder et al 2008)
